A Soldier's Home:

The Structures of Fort Tejon and their History

By George Stammerjohan and John Kelly (November 1988)

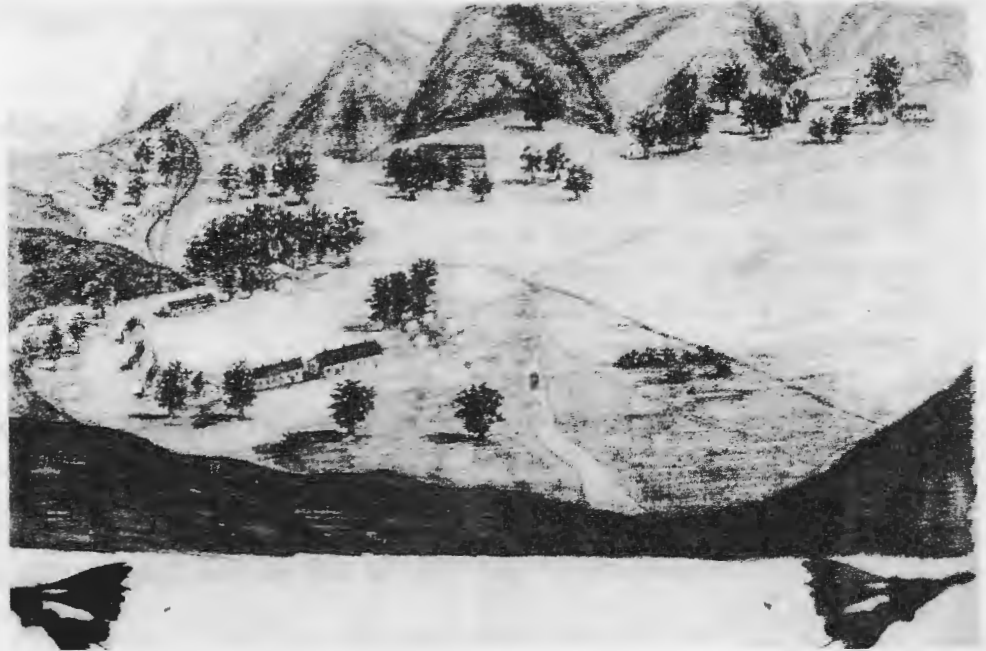
Contemporary sketch of Fort Tejon made by Brevet Major E. D. Townsend in October, 1855. View is looking north.

While few contemporary sketches of Fort Tejon exist. The one above was made by Brevet Major E. D. Townsend in October, 1855. In February 1859, Colonel Joseph K. F. Mansfield, Department of the Inspector General, visited Fort Tejon for a bi-annual inspection. His inspection report was accompanied by several sketch maps that showed to officials in Washington what was the basic layout of Fort Tejon and the surrounding countryside. The map, not drawn to scale by Colonel Mansfield, is reproduced on page. The Fort Tejon Map is updated to 1860 and numbered to correspond to the following building descriptions.

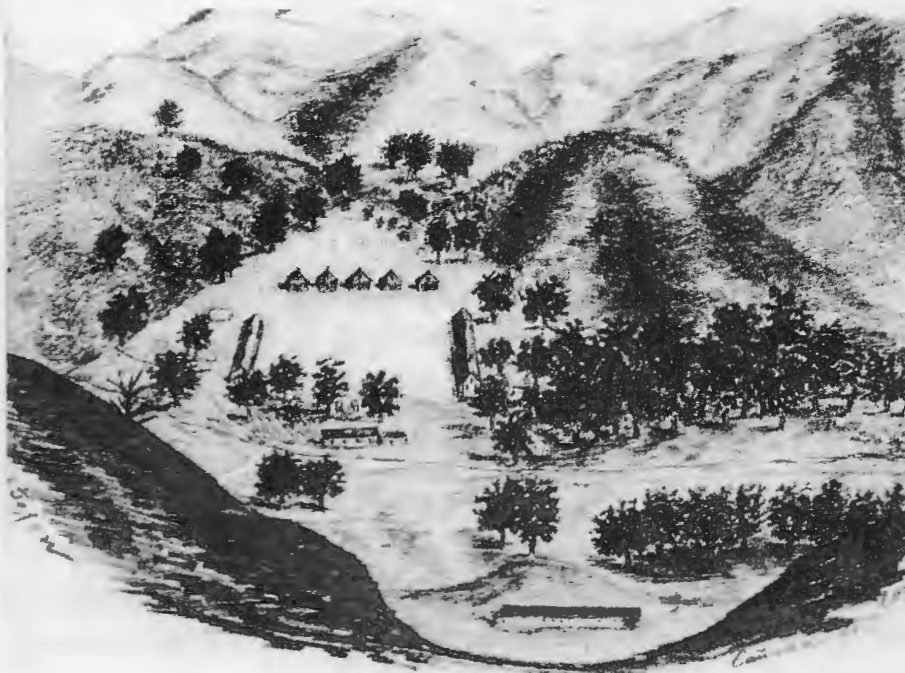
Contemporary sketch of Fort Tejon made by Brevet Major E. D. Townsend in October, 1855. View is looking southwest.

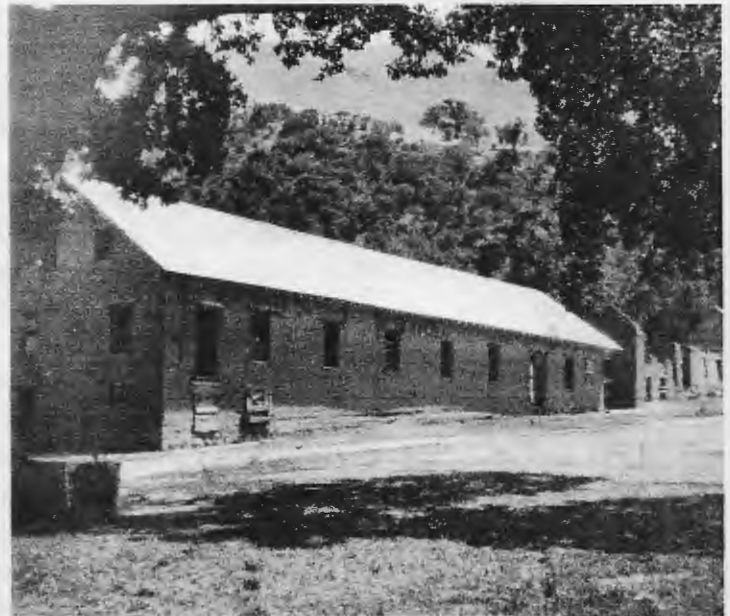
Barracks Building No. 1. Photo circa 1888.

7. Barracks 1. This building is one of only two standing structure at Fort Tejon which can be attributed to the period of army occupation, thus constituting a restored, and not reconstructed, structure. The adobe structure (112 feet long by 31 feet wide) was registered with the Historic American Building Survey in 1937. It was restored in 1948. The roof was raised, and pine shingles replaced the tin Tejon Ranch period roof. The gabled roof framework was saved and repaired. Approximately 40% of the western end was removed and replaced with modern adobe bricks manufactured from the remains of barracks 2. Floor planking was installed on the original joists in the east end and on replacement joists in the west end. Windows and doors were located and installed, and new stairs and landings constructed. The interior plastering was repaired and repainted.

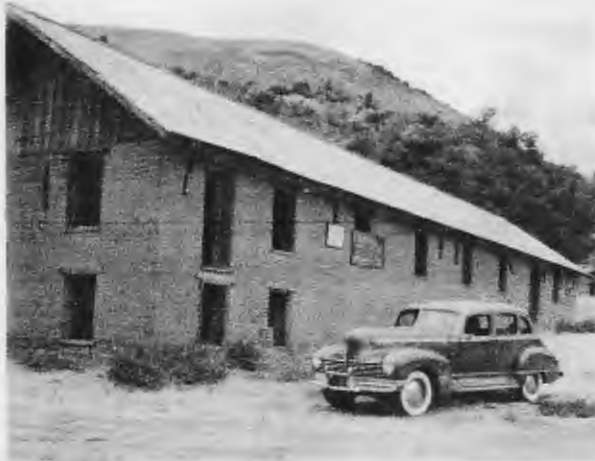
Barracks Building No. 1. Photo circa 1940.

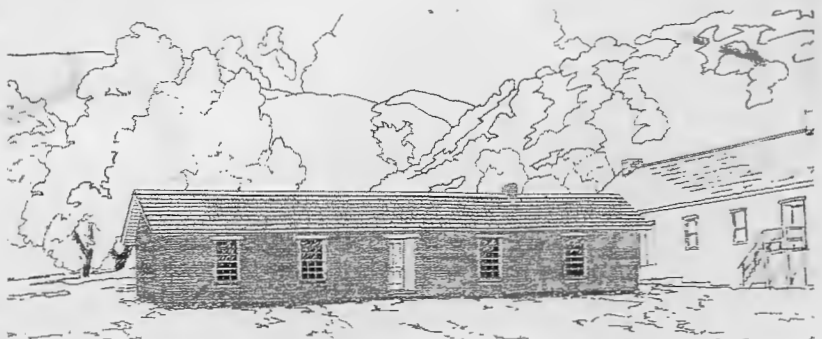
An artist's rendering of the Kitchen / Messhall with Barracks Building No. 1 in the background. By David Tinnon, 1999.

8. Kitchen/Mess. This structure consisted of a kitchen with a metal range, and a mess (or dining) room. The stone foundation was laid in 1856, and the adobe-walled, wood-shingle-roofed structure was

completed in 1857. The only surface remnant of this adobe structure is an amorphous mound of soil. This was the second detached kitchen/mess for barracks 1. Based on an incomplete topographic survey conducted in 1935, the stone foundation corners of this building show that it measured about 21 feet by 71 feet. These dimensions fit with the Mansfield Map and other descriptions.

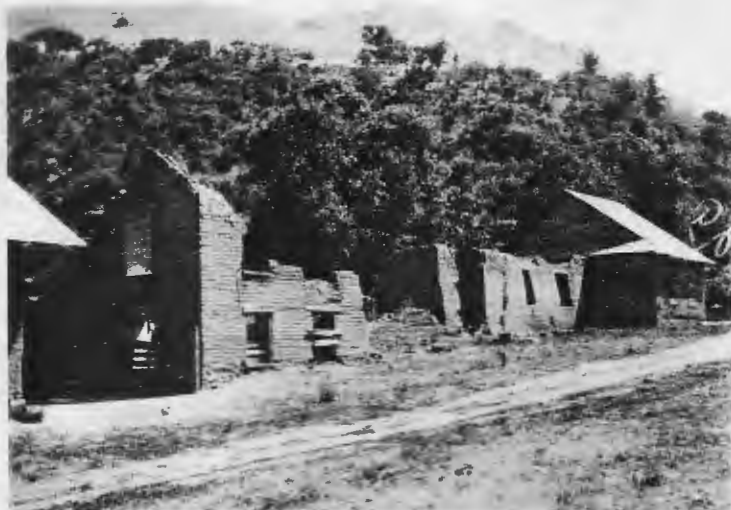
Ruins of Barracks Building No. 2 circa 1900.

10. Barracks 2. Begun in 1854 as a barracks, this structure was altered into a kitchen/mess in 1855 and realtered into a barracks in 1856, when it was decided to station two companies of troops at Fort Tejon. The structure survived into the 20th Century, the west end becoming the Tejon Ranch blacksmith shop. This end of the building survived until it collapsed during the 1956 earthquake. The foundation lines for the roughly "J"-shaped building are clearly seen on the surface, and two small adobe wall stubs can be seen along the front (north) side of the building near the west end.

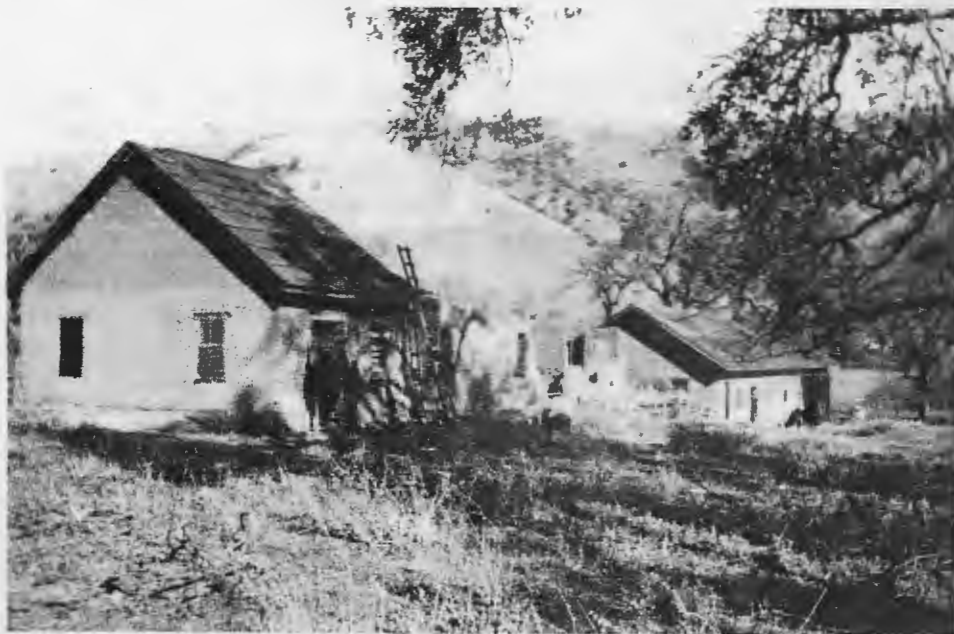
Barracks Building No. 2 showing southwestern end after being converted into a Blacksmith's Shop during ranch period.

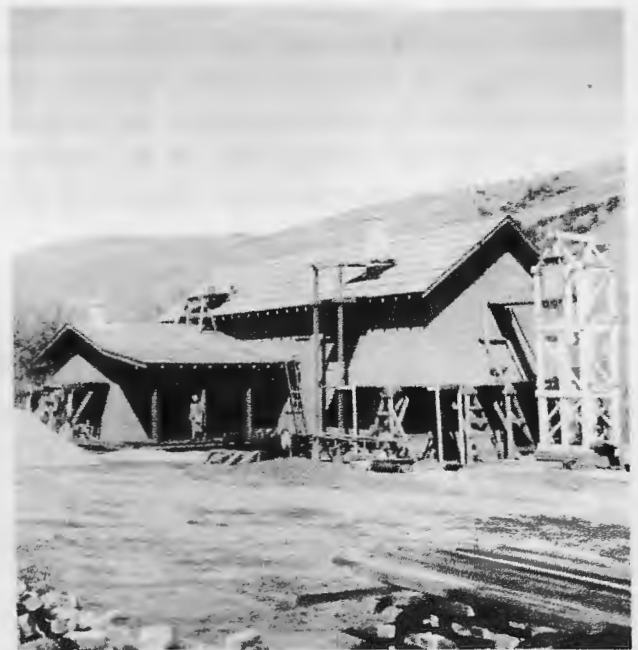
Reconstruction of Officers Quarters almost complete, circa 1957.

The building on site was constructed by the Department of Parks and Recreation during the period of restoration of barracks 1, 1948-53. Based on the

Mansfield Map and the 1935 incomplete survey, it appears that the current structure sits on the original stone foundation Foot print. Based on the 1937 HABS photograph of structure 16, the current adobe structure is a fairly accurate reproduction of the original building. It is a two-story adobe structure with partially finished cellar and a covered 'wood front (east) porch. Although attached by a shared wall, the kitchen can only be entered through an exterior south-facing door. This building is currently refurbished as an officer's residence and, along with barracks 1, constitutes the principal interpretation of army life at Fort Tejon.

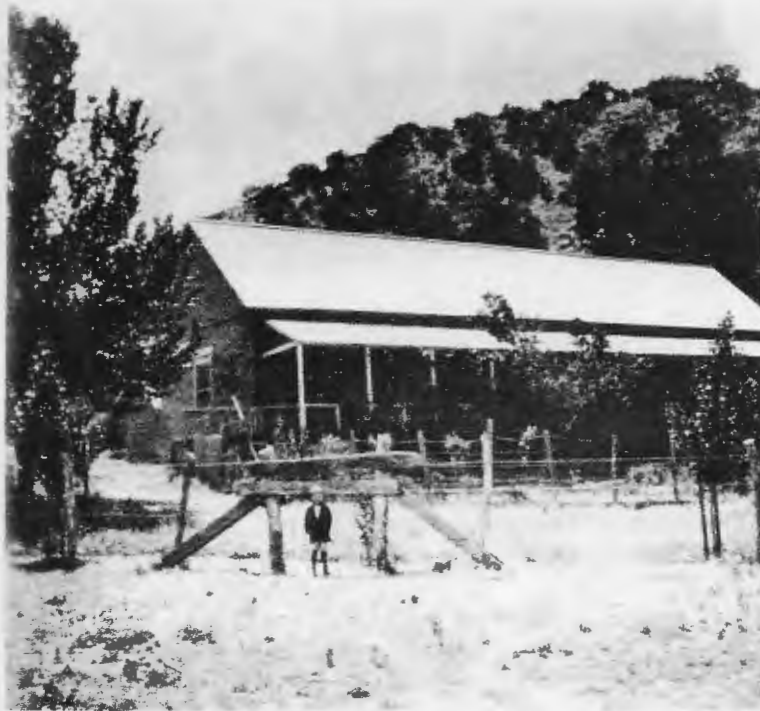
Central Officer's Quarters Building, circa 1900.

15. Officer's Quarters. This appears to be the southernmost structure on "Officer's Row. These three adobe buildings were probably one and one-half stories, with attached kitchen structures and pine shingles. These houses were started in early 1855 and finished in 1857. There is some debate centering on whether these were full two story structures.

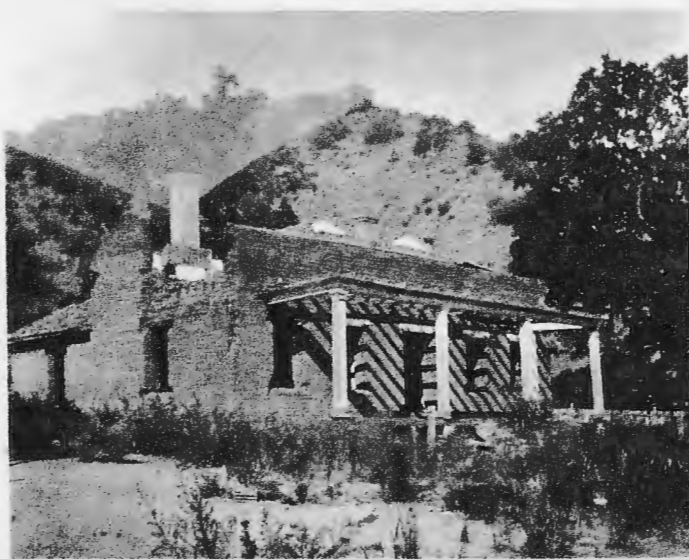
Westernmost Officer's Quarters, circa 1888. Showing signs of razing.

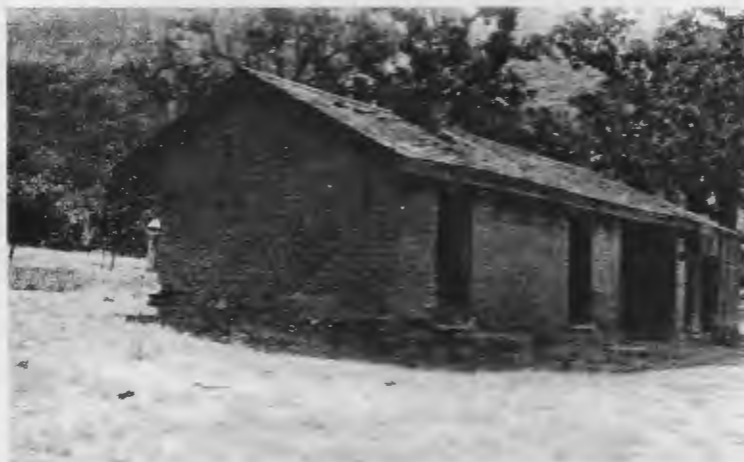
Officer's or Orderlies Quarters, circa 1940.

19. Officer's Quarters. This is a small standing adobe which is commonly called the "Orderly's Quarters". Recent research indicates that this two-room adobe with central fireplace was more likely junior officer's quarters and was possibly the last adobe building erected during the U.S. Army period at the post. The building had a wood frame addition during the ranch period, and the stone foundation from that addition can still be seen north of the adobe. It is not known whether the framed portion dates to the army period. The structure had been stabilized several times during state ownership, the most recent addition being external adobe buttresses after the building sustained earthquake damage during the 1960's. It is currently screened off and contains no

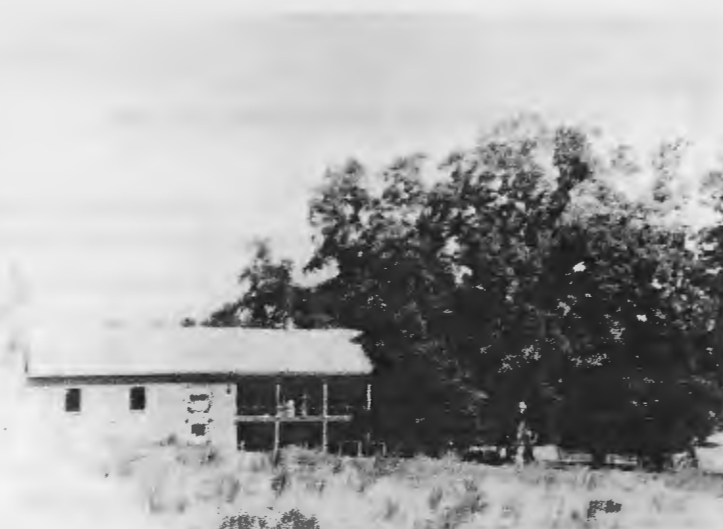
Hospital Building showing missing roof over southwest end of structure. Circa 1888.

20. Hospital. This adobe structure housed the post hospital, commissary, and ordnance storage and was 133 feet long by 33 feet wide. There were long verandas along both the north and south sides of the hospital portion (eastern three-quarters) of the building. The hospital may also have been the home of from two to four senior non-commissioned officers. There are photographs of the east end of the structure taken while it was used as a residence during the ranch period. Archeological research conducted on the hospital foundations in 1982 revealed a footprint which agrees with the incomplete survey of 1935 but disagrees with the Mansfield Map. The difference could be attributed to large wood-framed porch/veranda structures on three sides of the building.

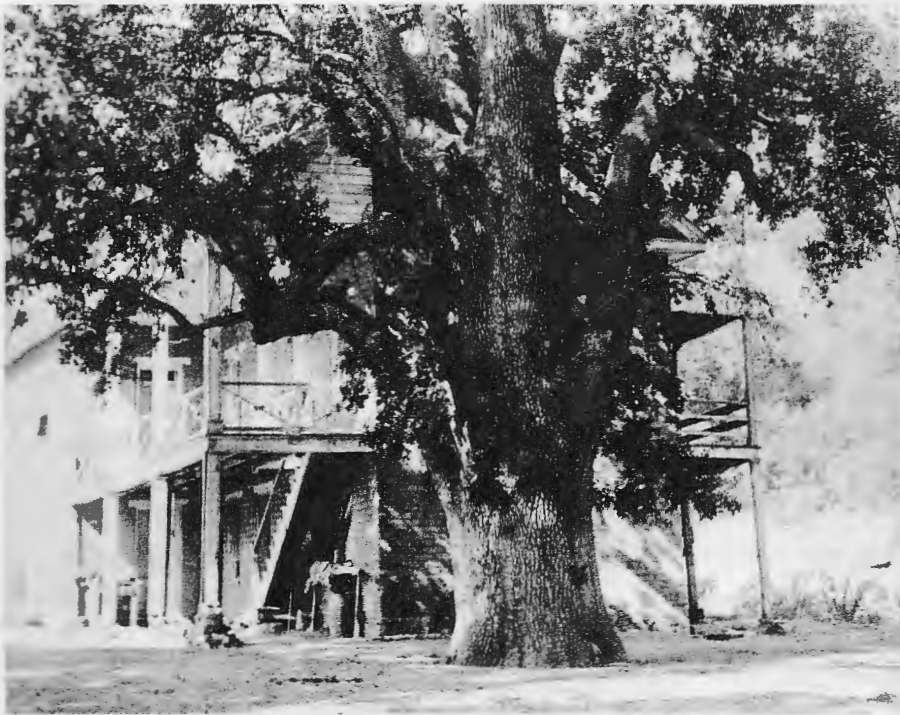
Hospital Building looking west. Circa 1888.

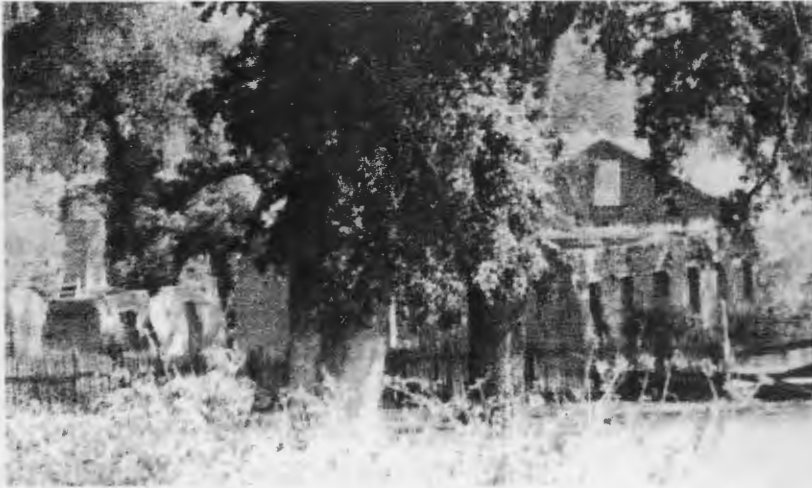
View of Jr. Officer's Quarters and detached Kitchen ruins. Circa 1888.

25. Officer's Quarters. Based on the Mansfield Map and the 1935 survey, this adobe structure was probably a junior officer's duplex with each half containing two rooms, with two hearths on a single flue. The structure is described as about 36 feet wide and 66 feet long. The 1935 survey supports these dimensions. All

that remains today is a single line of foundation stones imbedded in an adobe soil ridge along what would have been the south side, or front, of the building.

26. Kitchen. This detached adobe 28-foot by 28-foot kitchen exhibits two rough lines of foundation stones remaining along the south and west sides. Again, the original measurements are supported by the 1935 survey.

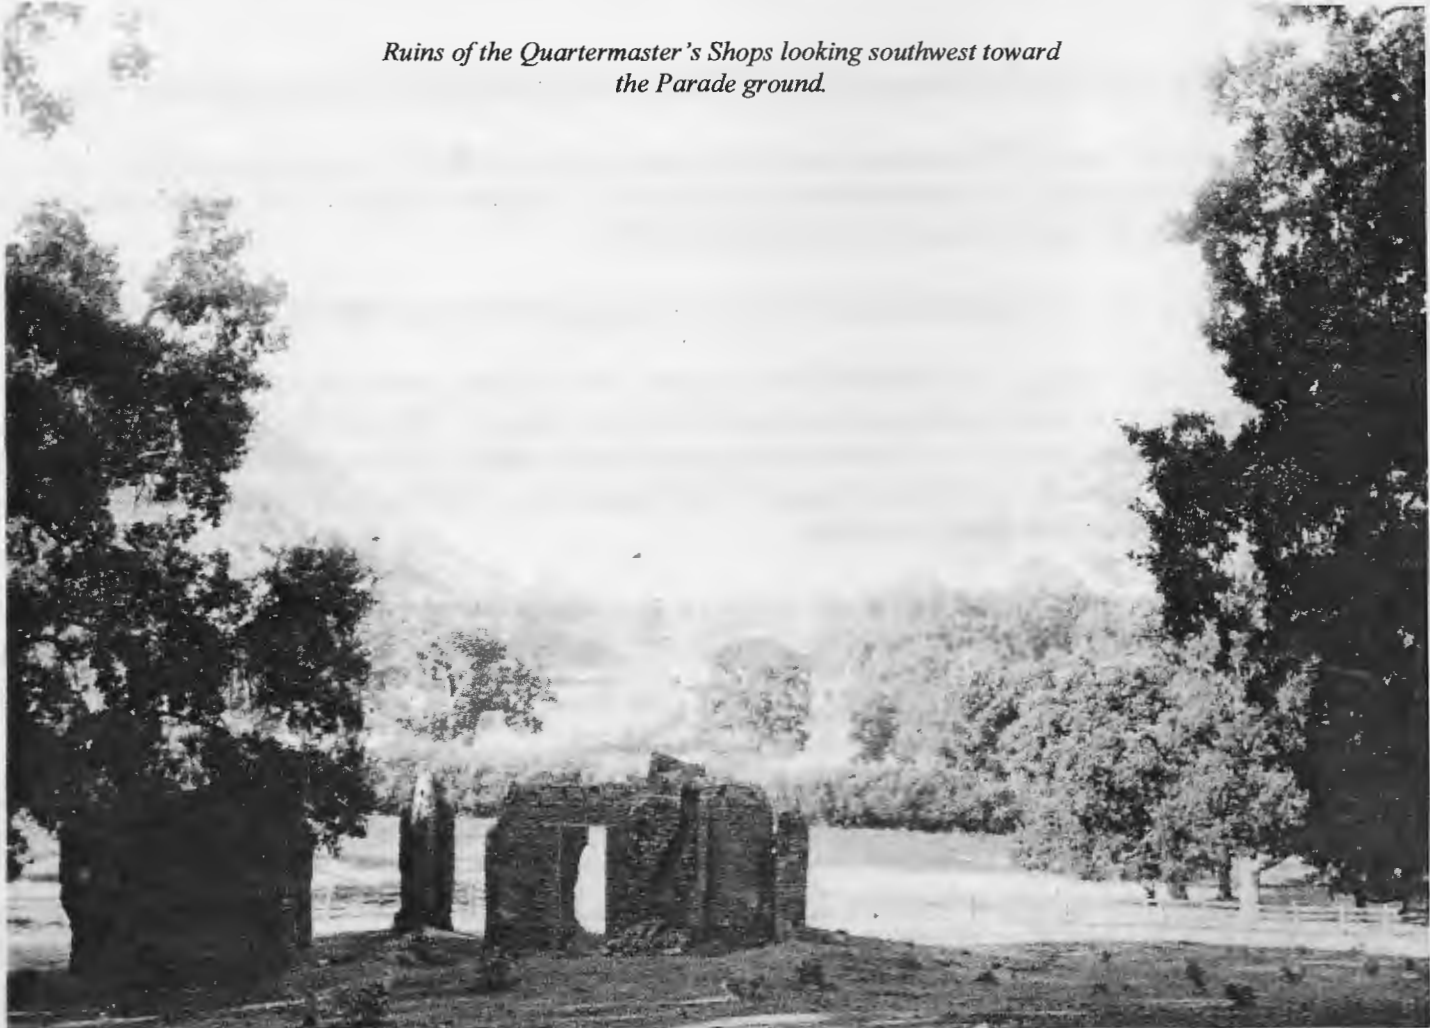
*Ruins of the Quartermaster's Shops looking southwest toward
the Parade ground.*

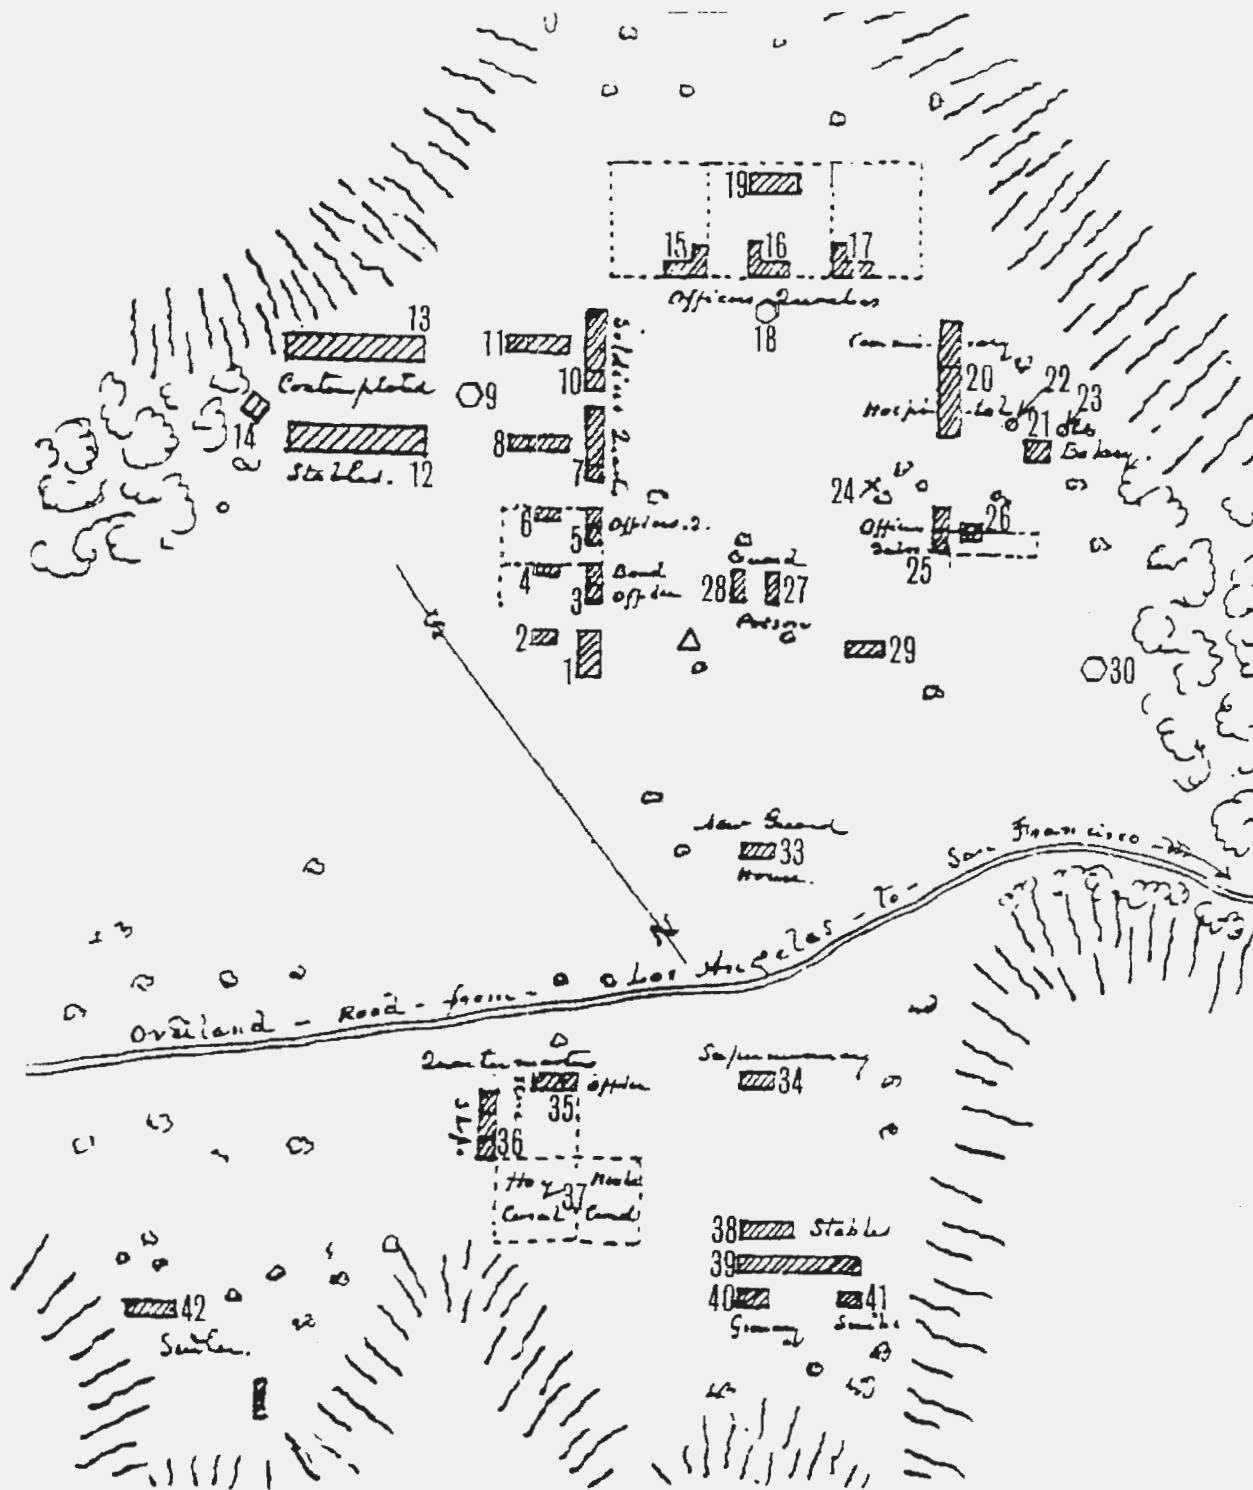
Fort Tejon Map

Drawn by *Colonel Joseph K. F. Mansfield*,
Department of the Inspector General
 on February 1859.
