**DEFENSE ENVIRONMENTAL RESTORATION PROGRAM
FORMERLY USED DEFENSE SITES**

**GRIZZLY CREEK CAMP
PLUMAS COUNTY, CALIFORNIA**

SITE NO. J09CA095800

SITE SURVEY SUMMARY SHEET
FOR
DERP-FUDS SITE NO. J09CA095800
Grizzly Creek Camp

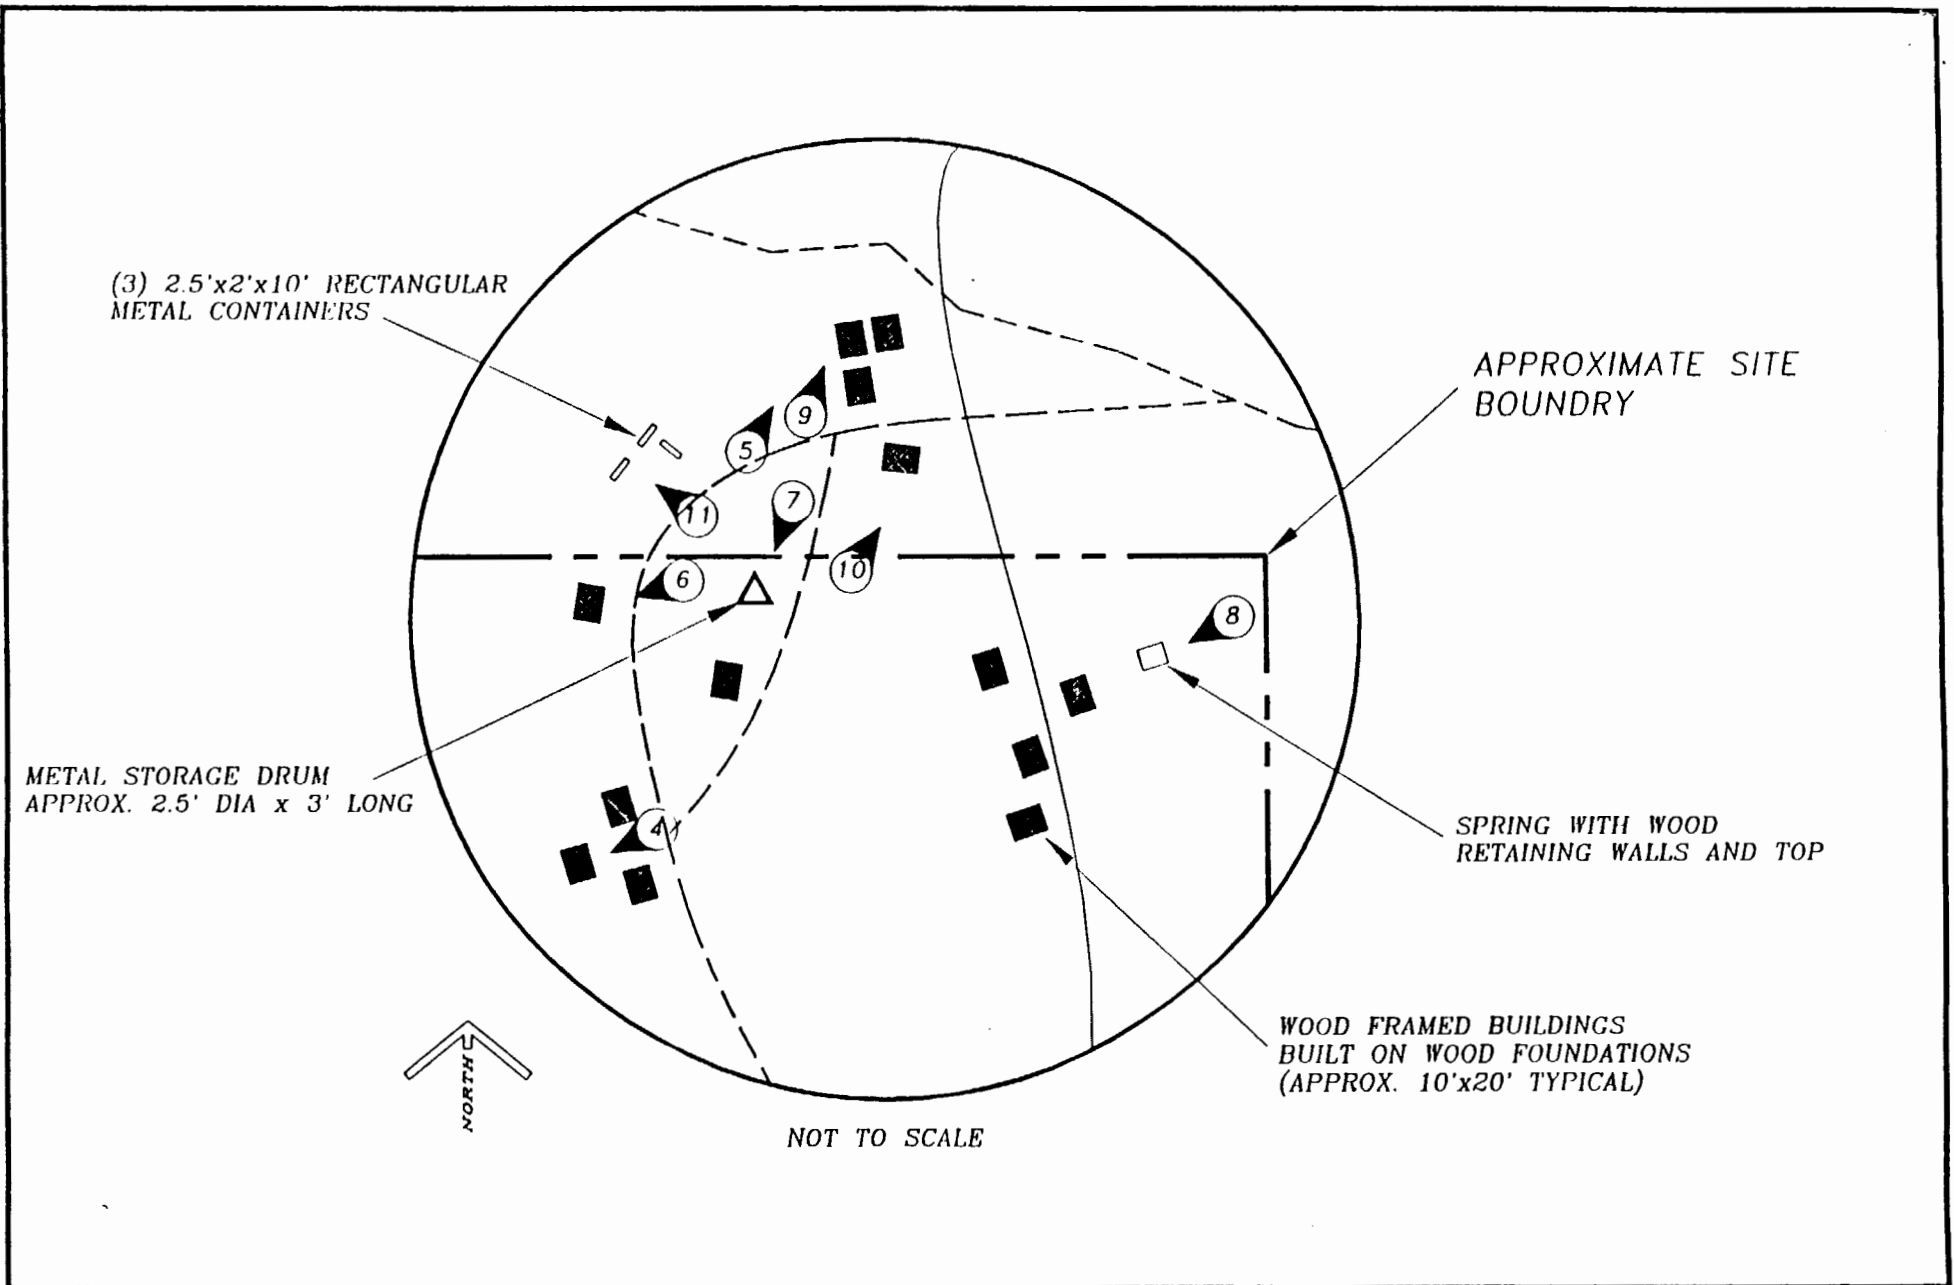
DETAIL 'A'
 VICINITY AND SITE MAP
 GRIZZLY CREEK CAMP
 PLUMAS COUNTY, CALIFORNIA
 Site No. J09CA095800

The site is located within the boundaries of the Plumas National Forest. Site usage is basically unchanged since it was retransferred to the Forest Service on 30 March 1966. The site survey was conducted by driving on public dirt roads, dirt logging roads and by driving on the Beckwourth-Genese and the Beckwourth-Taylorville gravel roads. Access to the northeast corner of the site was limited by lack of dirt or gravel roads in the general vicinity. The remnants of 13 wood-framed portable buildings, three rectangular metal containers, and one small drum were found on the border of section 13 and 24, Range 12 East, Township 24 North, Mount Diablo Base Meridian. Detail 'A' shows the approximate location of these improvements.

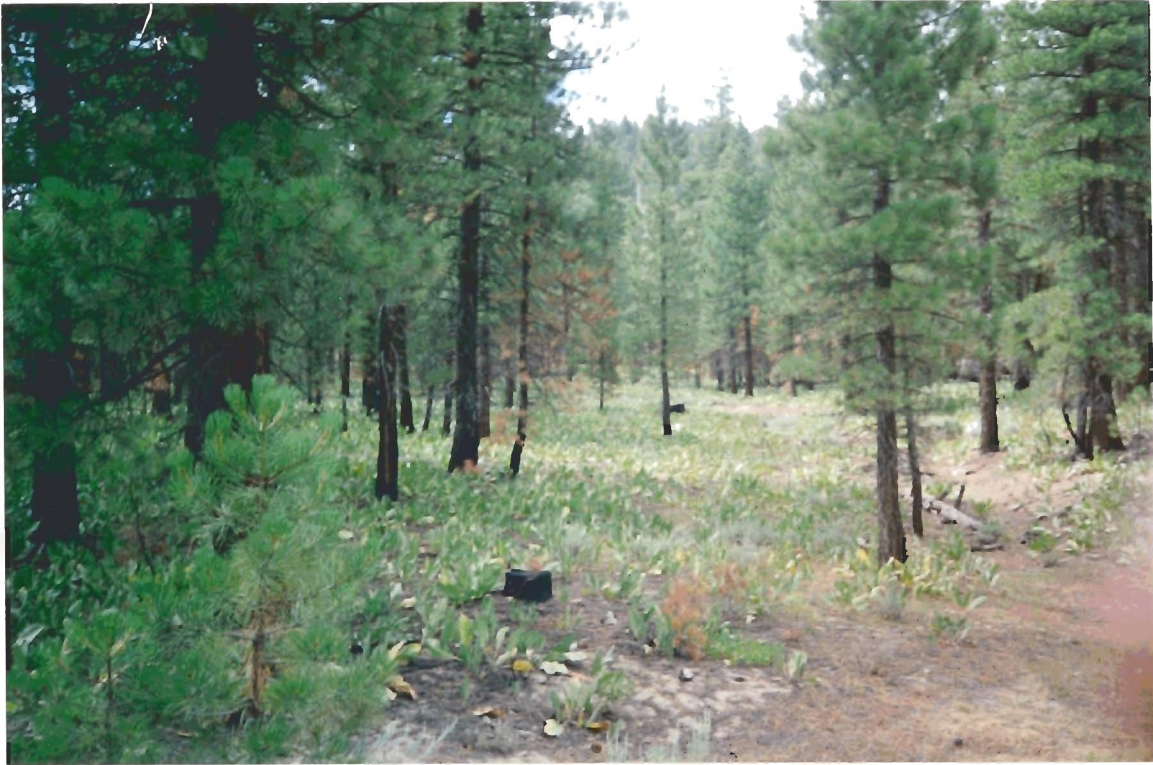
PHOTO 1

<u>PHOTO NO:</u>	<u>DESCRIPTION</u>
1	View of eastern site boundary to the north from the southeast corner, section 17.
2	View of central valley area of site to the north from the middle of section 24.
3	View of forested area to the north from center of section 23.
4	View of collapsed building to south-southwest, see Detail A.
5	View of three partially collapsed buildings to the northeast, see Detail A.
6	View of partially collapsed building to the west, see Detail A.
7	View of partially collapsed building and possible heating drum to south, see Detail A.
8	View of wood framed spring with wood lid and collapsed building to the southwest, see Detail A.
9	Closeup view of three partially collapsed buildings to the northeast, see Detail A.

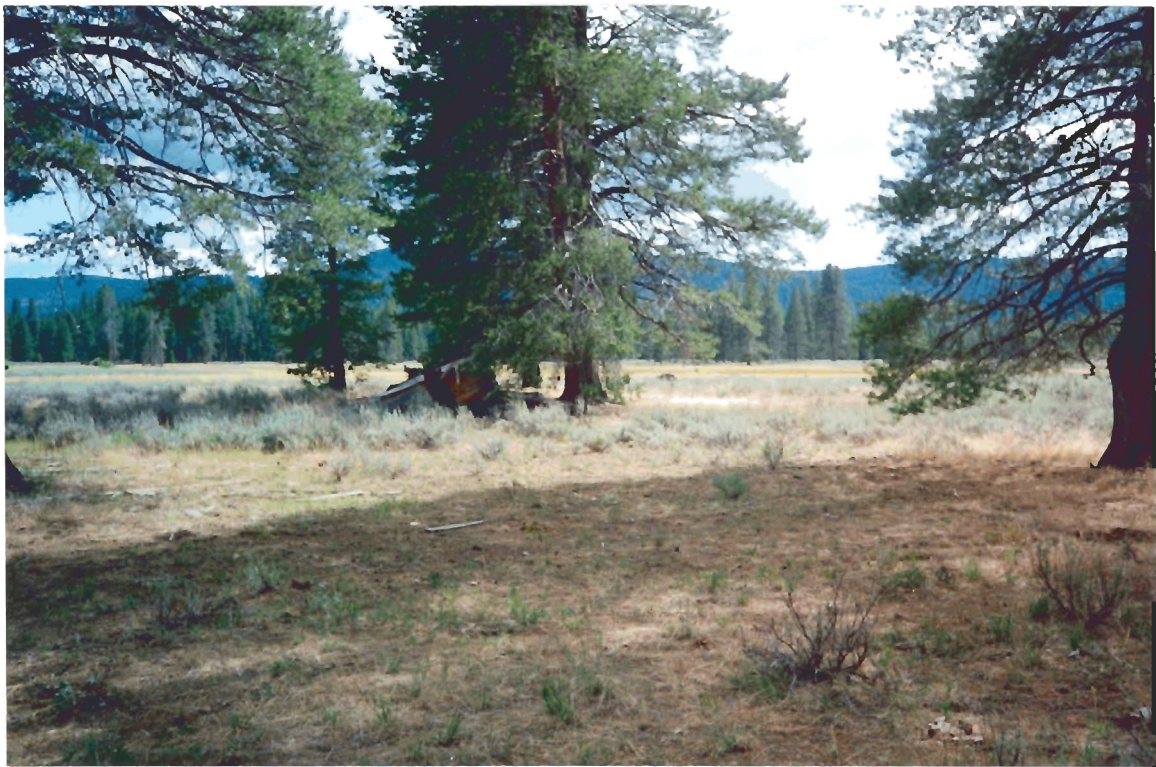
PHOTO 4

The wood-framed, portable buildings are approximately 10' X 20'. They are in extremely poor condition with no evidence of maintenance. Three of the buildings are entirely collapsed and the wood is highly decomposed. The remaining ten buildings are in serious danger of collapsing with bulging walls and sagging ceilings.

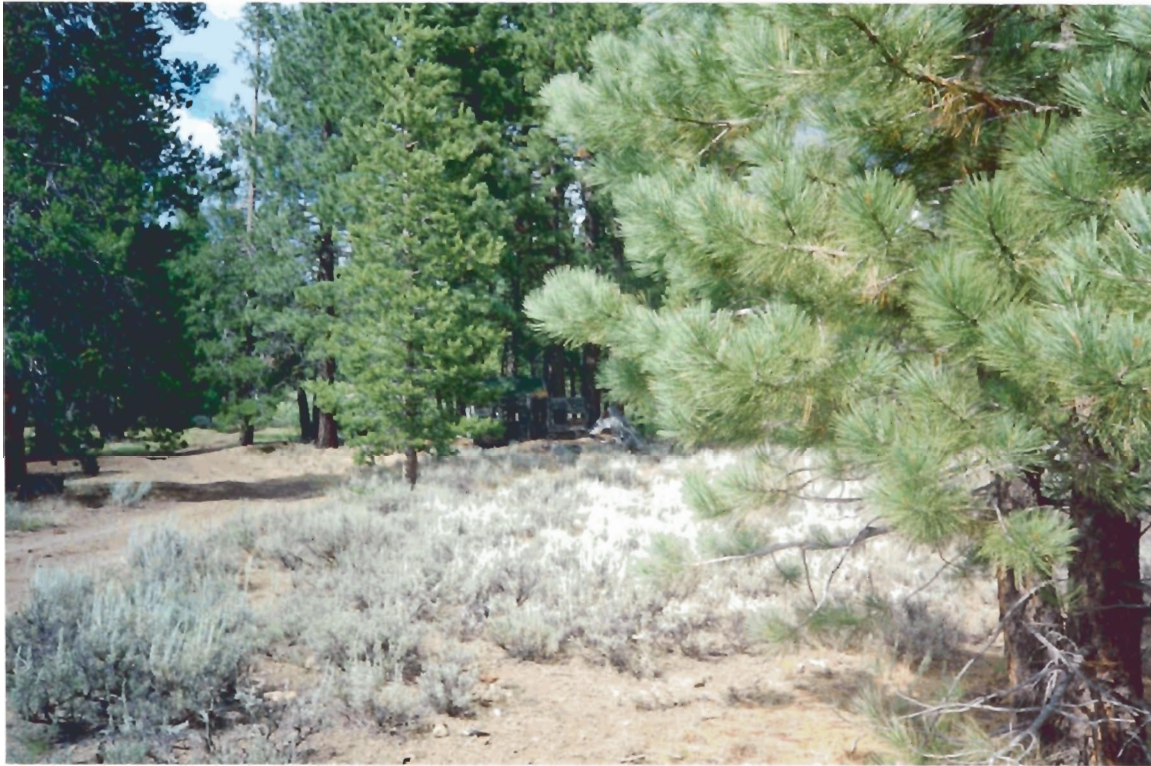
PHOTO 10

- 10 View of partially collapsed building to the northeast, see Detail A.
- 11 View of three rectangular metal containers to the northwest, see Detail A.
- 12 View of logged area to the northwest from the southeast corner of section 13.
- 13 View of logged area to the south from east, center of section 13.
- 14 View of Lake Davis and southeast corner of section 19 from Beckwourth Genese Road, section 18.
- 15 View of forested mountain and valley to the northeast from the southwest corner of section 12.
- 16 View of forested mountain to the north-northeast from the center of the southern border of section 12.

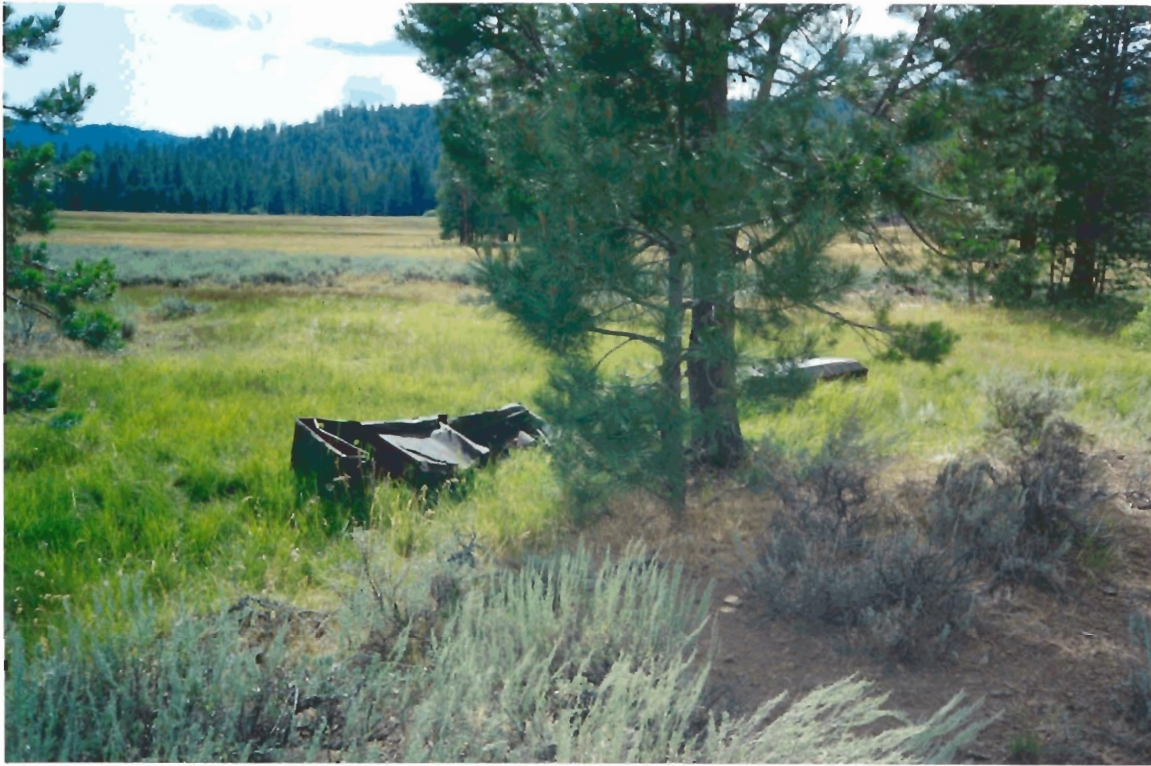
PHOTO 11

The three rectangular metal containers were approximately 2.5' high, 2' wide and 10' long. The

metal was dented and highly corroded, with several areas rusting completely through. These containers appeared to be sinks with a wash basin on either end.
