### **ARCHIVES SEARCH REPORT**

## MARCH AIR FORCE BASE AND ASSOCIATED SITES

Riverside, California

SEPTEMBER 1994

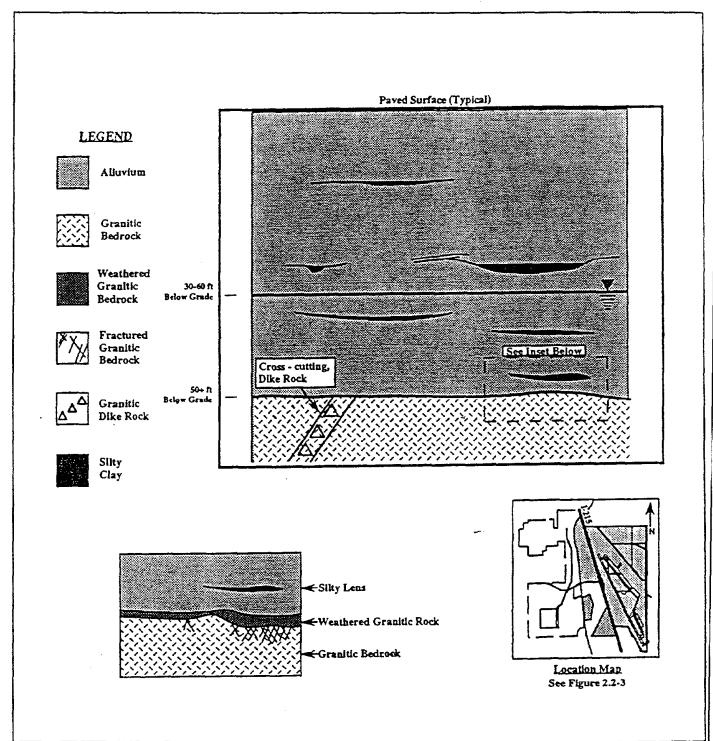
Figure 4.1. Generalized schematic of alluvial aquifer at March Air Force Base, California. Schematic does not represent relative frequency or areal extent of silty leses. Paved surface is flightline runway/taxiway. (After Tetra Tech, Inc., 1992.)

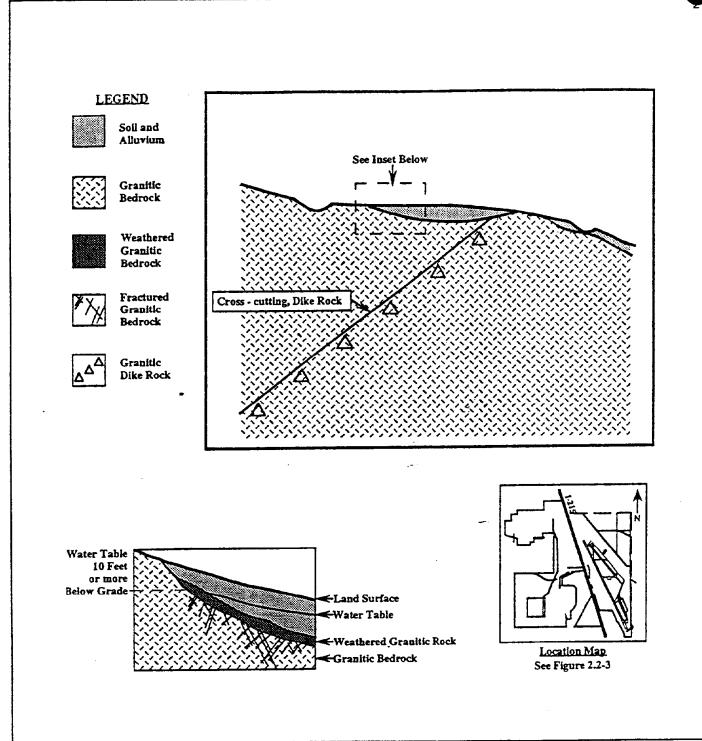
Figure 4.2. Generalized schematic of geology of Perris Erosional Surface showing relationship of ground water surface to topography and bedrock surface. (After Tetra Tech, 1992.)

Surface and bedrock topography determine the depth and gradient of ground water in the portion of the site on the Perris Erosional Surface Figure 4.2.) The crystalline bedrock underlying the site is not considered to be a ground water producer. The ground water surface occurs in the soil overlying bedrock sub-parallel to the bedrock and ground surface. Depth to ground water varies from at or near the ground surface to 40-feet BGS. Several small marshy areas and seasonal springs exist in the western portion of the site. Drainages have been modified by recent residential developments in the area as well.

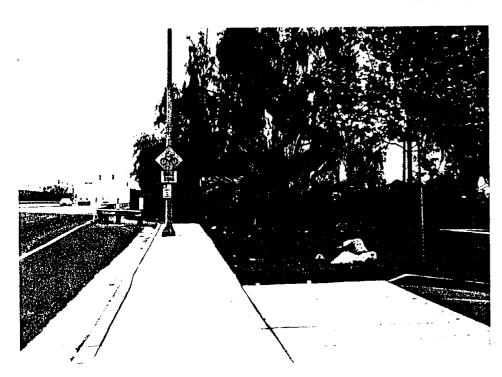
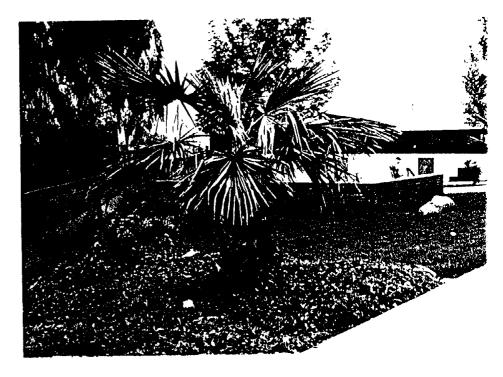
THESE PICTURES REPRESENT THE LAND UPON WHICH
THE PUMP HOUSE WAS LOCATED FOR THE NORTHERN
SECTION OF THE WATER SYSTEM ANNEX. THE SOUTHERN
SECTION FROM LAKE MATHEWS TO MARCH A.F.B. IS
STILL ACTIVE THEREFORE NO PHOTOGRAPHS WERE
TAKEN OF THIS SECTION.

- 5. The Lake Mathews to M.A.F.B. portion of the March Water System Annex is used to supply water to the Base from Lake Mathews. The Riverside to Camp Haan (now M.A.F.B.) portion is abandoned and the area where the pump house stood is now developed property with retail stores. No evidence was found of unsafe debris, hazardous or toxic waste, or unexploded ordnance resulting from DOD use of the site. The California Regional Water Quality Control Board and the County of Riverside Department of Health have no record of hazardous or toxic waste on the site.

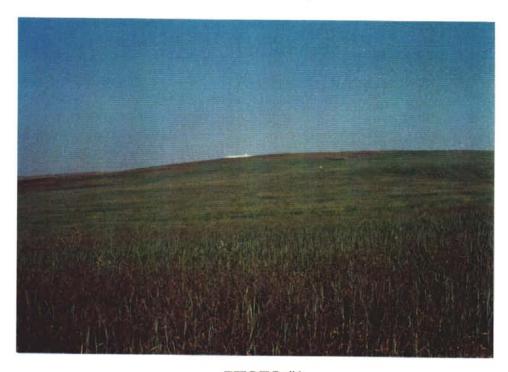
PHOTO #1
TRENCH (AMMUNITION DISPOSAL PIT) SOUTH OF MAGAZINE AREA
(Facing East Towards Water Tower)

There is one feature of interest, located south of the magazine area. It is seen as a small bare area (about 75' by 75') with a small pit (about 20' by 40') at the south edge and a small black object near the center of the area. The feature is seen only on the 1980 photography. It is not there on the 1966 photography and is covered by new development (drainage ditch/structure) on the 1989 and 1992 photography. This feature may be either a burn area or a burn/burial area. Configuration of the bare area/pit/object is similar to that seen in a larger bare area which is located about 1000 feet east of the weapons storage area.

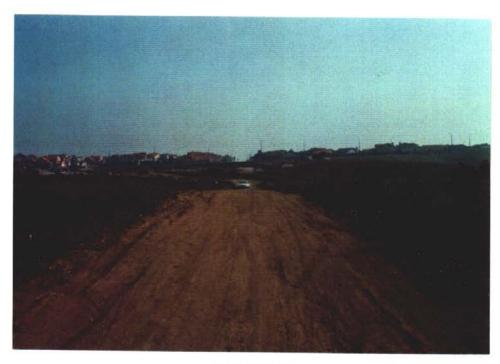
PHOTO #2
TRENCH (AMMUNITION DISPOSAL PIT) SOUTH OF MAGAZINE AREA (Facing South)

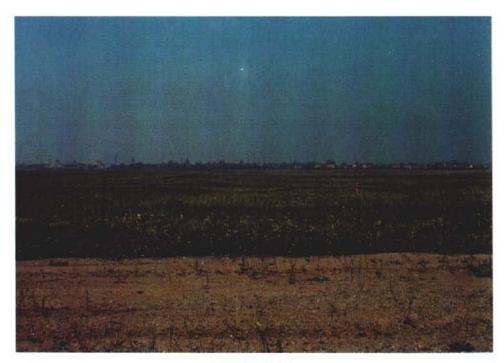
PHOTO #6 SKEET RANGE (Facing North)

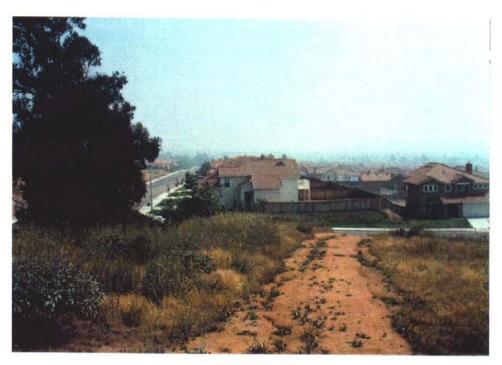
PHOTO #9 RIFLE RANGE (Facing South)

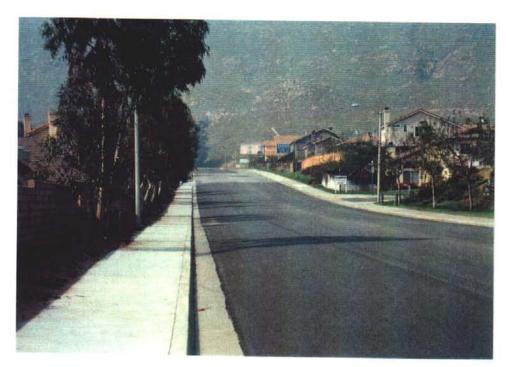
PHOTO #11 RIFLE RANGE (Facing North)

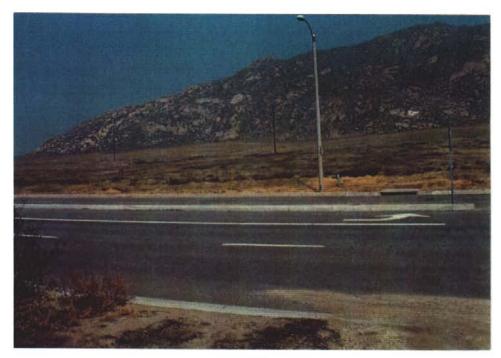
PHOTO #15 POORMAN RANGE (Facing Northeast)

After the research was completed, the team acquired Quad maps and performed a site visit on the FUDS properties of March AFB. The team drove to the Poorman Range first. This area is now a small park near a residential area. No ordnance was discovered. Next, the team drove to the rifle range. This area is all residential. No ordnance was discovered at this FUDS location either. Just north of March AFB was property which was used as a safety fan for a skeet range. This area is still an open field. A portion of this field had been plowed and was in crop. No ordnance was found. The team then drove to the location of the ammunition disposal area. The location of the pit is a field with drainage ditches throughout. Just northwest of the pit is a water tower and drainage structure. Just to the south is residential. Within the field, in the area of the former disposal area, were several children playing and riding their dirt bikes. No ordnance was discovered on the surface.

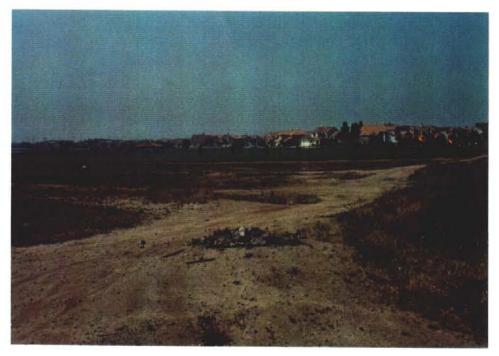
PHOTO #16 POORMAN RANGE (Facing Northwest)
