Historic Preservation Treatment Plan for the Nacimiento Ranch House, Camp Roberts

Historic Preservation Treatment Plan for the **Nacimiento Ranch House** Camp Roberts, California

May 1999

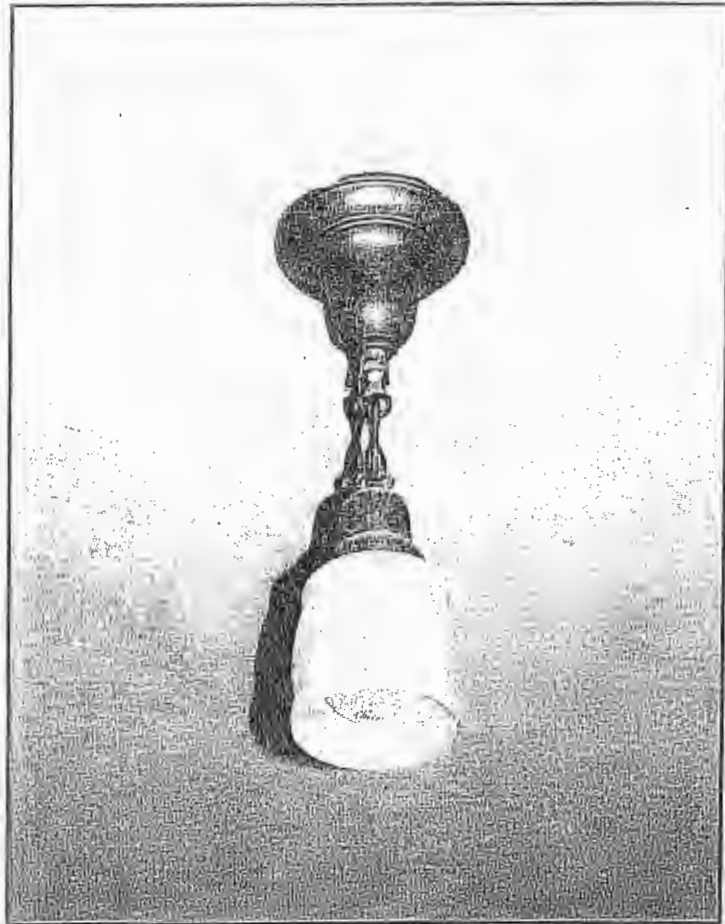
Figure 7. Original Interior Light Fixture

The interior plan of the building has a central block with a dining room, living room, kitchen, and pantry and two wings containing sleeping areas and bathrooms. The south wing has two bedrooms and one bathroom, whereas the north wing is currently divided into three bedrooms and one bathroom. All of the rooms originally had painted plaster walls and lathe and plaster ceilings. The floors have a subflooring of tongue and groove fir covered with linoleum or carpeting. The main sources of lighting throughout the house are hanging electric light fixtures (Figure 7).

- wooden cabinets, shelving, and vented produce pantry in the kitchen;
- swinging wooden door between the kitchen and dining room;
- built-in wooden bookcases in the dining room;
- fir subflooring;
- lathe and plaster ceilings;
- painted concrete/plaster walls;
- a large fireplace faced with rocks; and
- hanging frosted light globes (Figure 7)

- Cracked or broken light fixtures will be replaced with salvaged or reproduction fixtures similar to those made during the late 1920s or 1930s. Many lighting shops have such reproductions or deal with companies that manufacture them. Companies dealing with salvaged or reproduction lighting fixtures include American Home Supply in California, St. Louis Antique Lighting Co. in Missouri, and Historic Home Supply Corp. in New York (Appendix A).
